WRDC-TR-90-4091

X-RAY TOMOGRAPHIC INSPECTION OF
PRINTED WIRING ASSEMBLIES AND ELECTRICAL COMPONENTS

Boeing Aerospace & Electronics
P.O. Box 3999
Seattle, WA 98124

Interim Report for Period July 1989 to June 1990

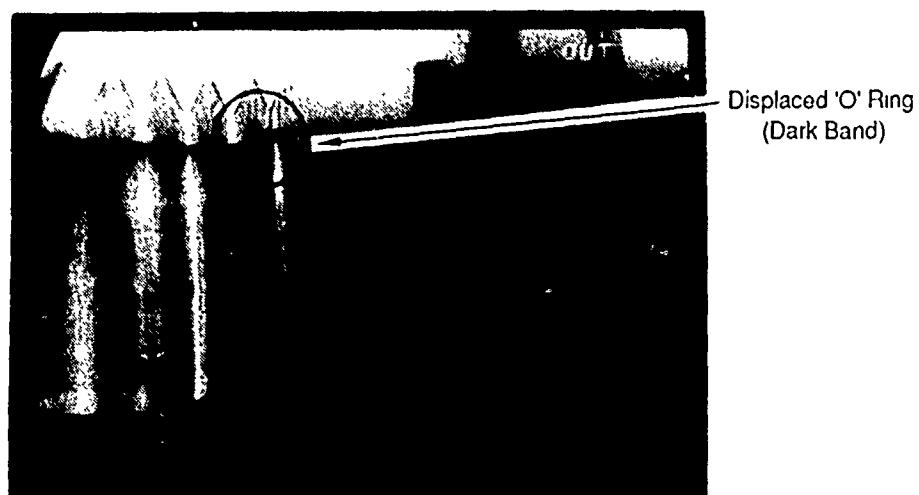
Figure 4.1-6 Radioscopic image showing displaced "O" ring

For comparison, the connector was imaged with a microfocus radioscopy system. Figure 4.1-6 shows the displaced "O" ring among the superimposed features. The use of radioscopy in failure analysis can be very effective but requires manipulation of the part and experience in interpretation of details in the projected image.
